GENERAL ELECTRIC

OUTDOOR

POWER EQUIPMENT

E8M/E10M ELEC-TRAK TRACTOR AUDIT

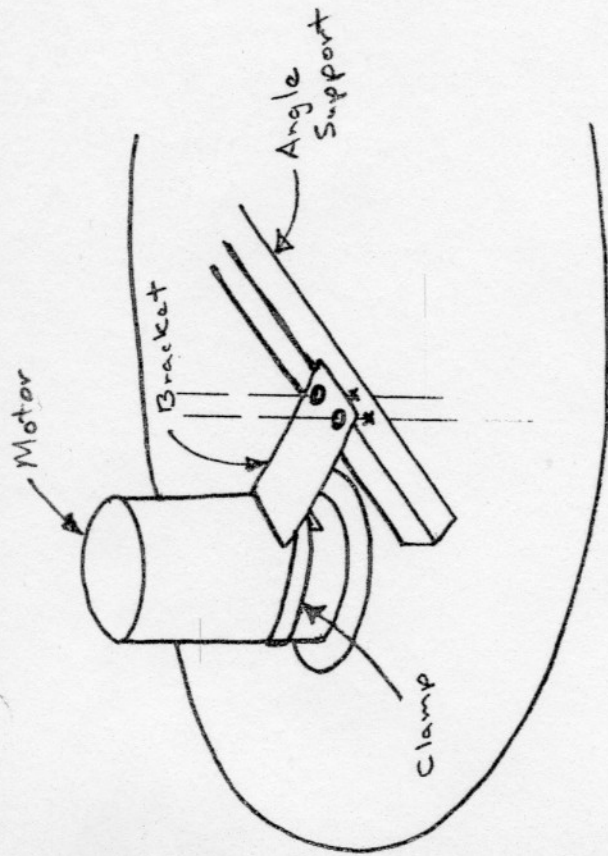
The mower motor modification effectively eliminates vibration and noise caused by any imbalance in the blades. The addition of a clamp and bracket to each motor effectively anchors the motors at a second point and minimizes any vibration that may occur. All mowers manufactured through June, 1972 should be modified as follows:

1. With the mower removed from the tractor, assemble one clamp around the motor near the base. Place a bracket as shown in the Figure 1A and secure with the clamp.

2. Using the bracket as a drill jig, drill 2 holes using a 0.28 (9/32) inch drill bit through the angle support of the mower. Use care to prevent marring the mower housing when the drill bit penetrates the angle support.

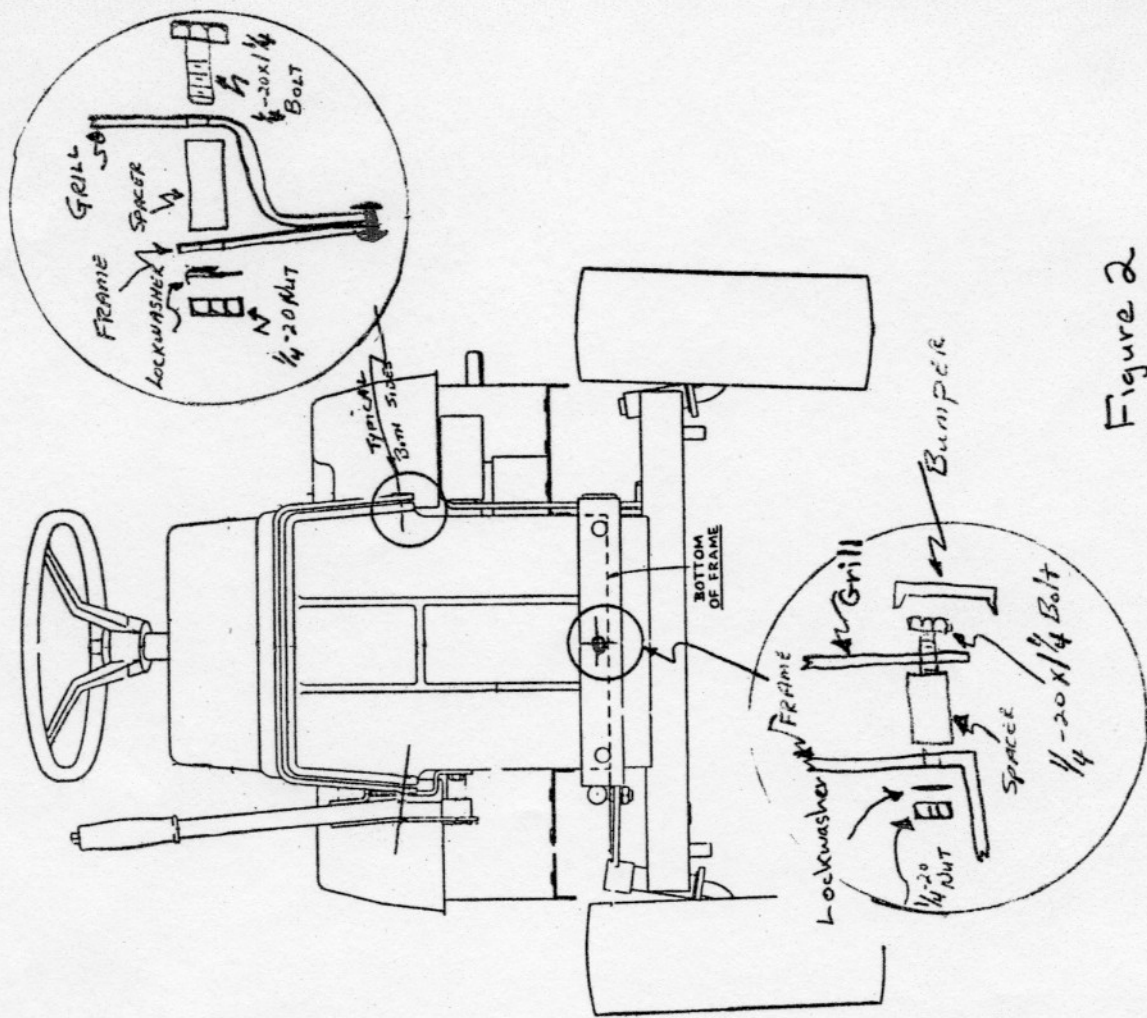
Three additional support points are to be added to the grills on all E8M and E10M Elec-Trak tractors manufactured through June, 1972 as follows:

1. Remove front battery and bumper.
2. Center punch the sides of the grill at a point as shown in Figure 2, so that subsequent drilling will allow the placement of a spacer between the grill and battery compartment as shown in Figure 2. Make sure the punch mark is located so the drilled hole will not tear through the edge of the grill or compartment wall.

3. Drill a 1/8 inch pilot hole at each punch mark and then drill a 0.281 (9/32) inch hole at each pilot hole making sure the drill bit passes through the battery compartment perpendicularly. See Figure 2 insert.

4. Force a spacer between the holes in the grill and compartment wall and secure with a 1/4-20 x 1 1/4 inch bolt, lockwasher and nut with the bolt head on the outside of the grill. Repeat for other side.

5. Center punch a point in the center lower edge of the grill so subsequent drilling will enter the front battery compartment as shown in the insert of Figure 2.

6. Drill a 1/8 inch pilot hole at the punch mark and then drill a 0.281 (9/32) inch hole at the pilot hole making sure the drill bit penetrates the compartment wall perpendicularly.

7. Force a spacer between the holes in the grill and compartment wall and secure with a 1/4-20 x 1 1/4 inch bolt, lockwasher and nut with the bolt head on the outside of the grill.
