ElecTrak[®]

PRODUCT SERVICE BULLETIN NO. OPSB 74-1

February 22, 1974

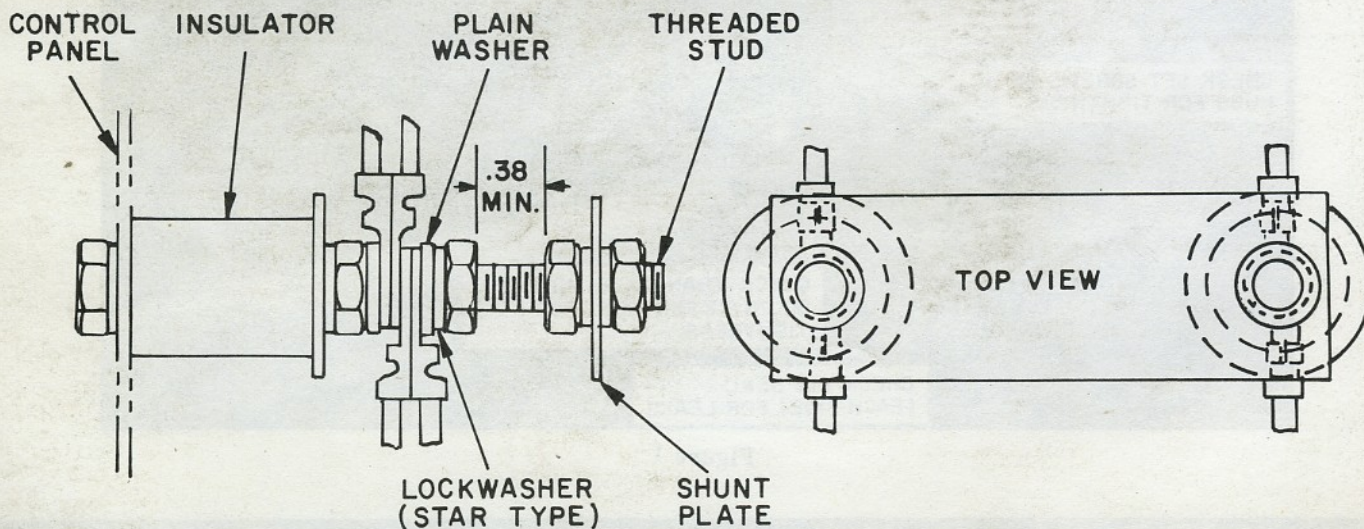
Figure 2

It has been reported that some E20 tractors have developed overheated current sensing shunt plates (lower control panel). Indications are "chattering" of the FW relay or loss of the top three throttle speeds in the forward direction. In severely heated cases, the drive motor won't start in forward or reverse even though the controls can be heard to pick up in normal fashion. An examination of the shunt plate should be made for evidence of overheating. If "warping" or discoloration is evident, then replace the shunt.

Loose shunt connections at time of assembly or loosening from vibration at the threaded phenolic spacers will generate heat when current flows through the shunt. For this reason it is imperative that, when replacing the shunt plate, the wires at the shunt be examined and wire terminals replaced if overheated.

A new Shunt Kit is available, as shown in Fig. 2. Use part number 247A7693G2 when ordering. This new kit assures a tighter, more reliable connection by using different lock washers and eliminating the use of the insulator threads for electrical connections. See Fig. 2.
